USE OF REINFORCED EARTH® FOR REPAIR OF THE JAMESVILLE DAM

BERNARD E. BUTLER, P. E.

Associate Soils Engineer
New York State Department of Transportation
Soil Mechanics Bureau

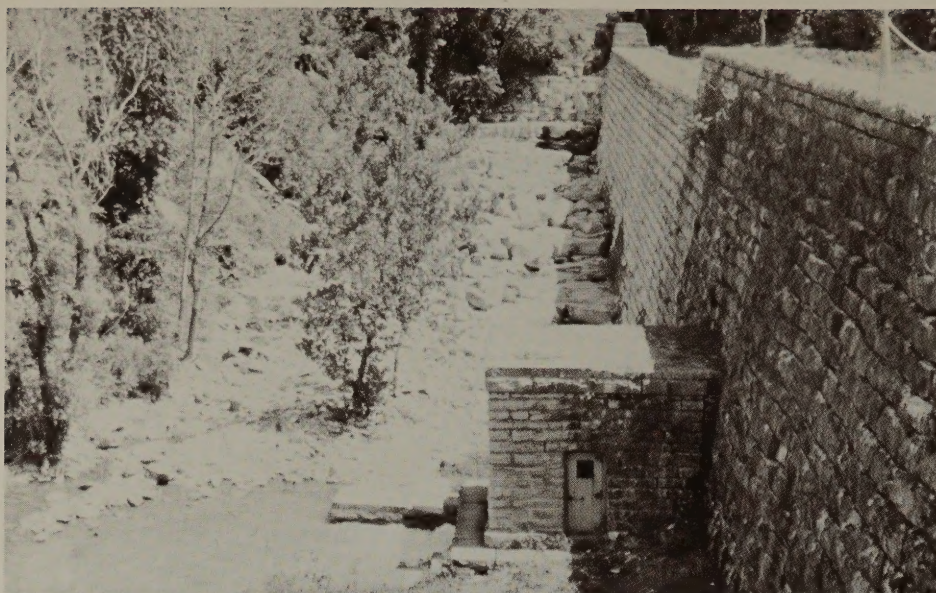
Figure 2. Jamesville Dam before repairs.

The dam is situated on the Butternut Creek south of Jamesville (See Figure 1). Design and construction of the dam took place between 1872 and 1874. It is a stone masonry gravity structure about 500 ft long, incorporating a 200 ft overflow spillway on the east side. The maximum height is about 48 ft, measured from the bottom of the foundation. The foundation beneath most of the dam is limestone. However, the 40 to 50 feet of dam length next to the west abutment is supported on timber piles with a timber cut-off wall to rock. An overall view of the front of the dam is shown in Figure 2.

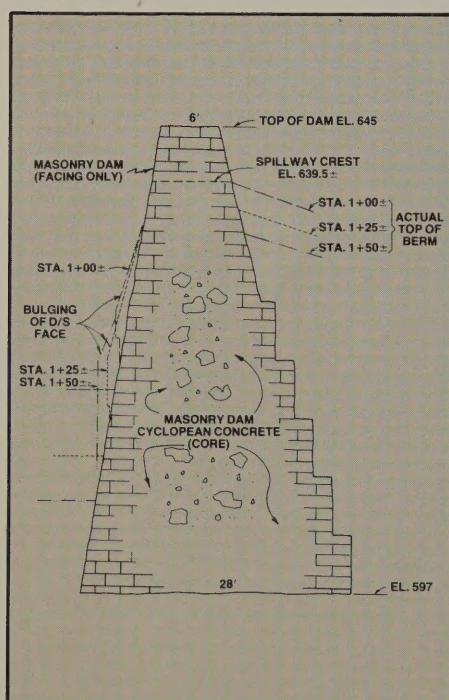
Figure 3. Typical section—Jamesville Dam.

The dam's internal structure was revealed by three horizontal and three vertical borings made through it immediately after the Phase I inspection report. While outward appearances and the plan information indicated that the dam was entirely stone masonry, the borings showed the interior to be of cyclopean construction: concrete with limestone fragments used as bulk filler. This meant that the exposed masonry was both facing material and formwork for the interior filling. The cross-section is shown schematically in Figure 3. There is no available recorded evidence authorizing a change in cross-section.

After the Phase I report, many site inspections were made of the dam exterior. The main cause for concern was a general bulging of the downstream masonry facing. Figures 4 and 5 show the bulging blocks and open deep joints. This outward movement, amounting to as much as a foot (See Figure 3), has been largely attributed to freeze-thaw cycles of water behind the blocks. The area of movement was generally outside the limits of the overflow spillway, beyond the gatehouse, extending to the west abutment. Water seepage and occasional flows had also been observed from open joints between blocks. The absence or deterioration of mortar in joints was extensive. However, in spite of these losses, maintaining the pool had never been a problem.

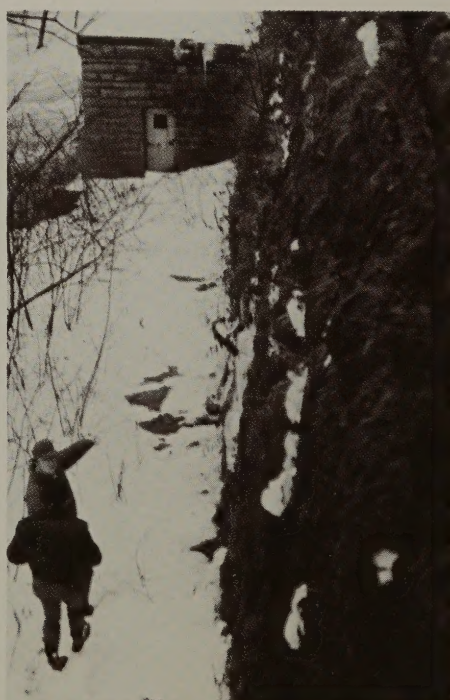
Figure 4. Bulging of down stream face.

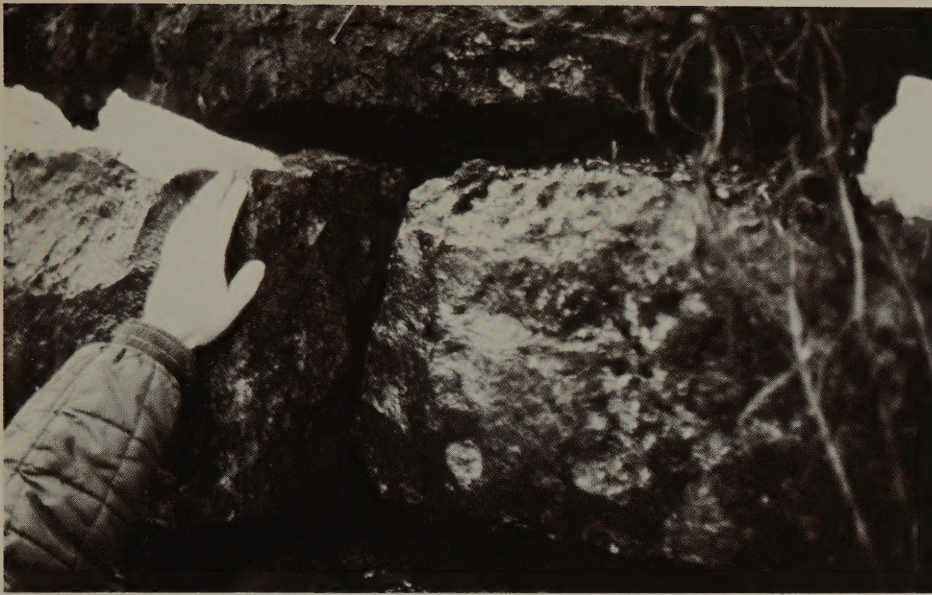
Figure 5. Open joints in down stream face.

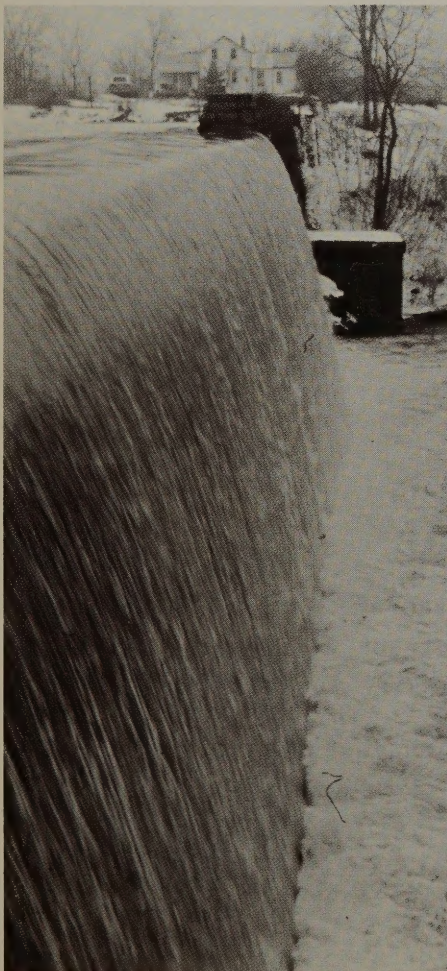
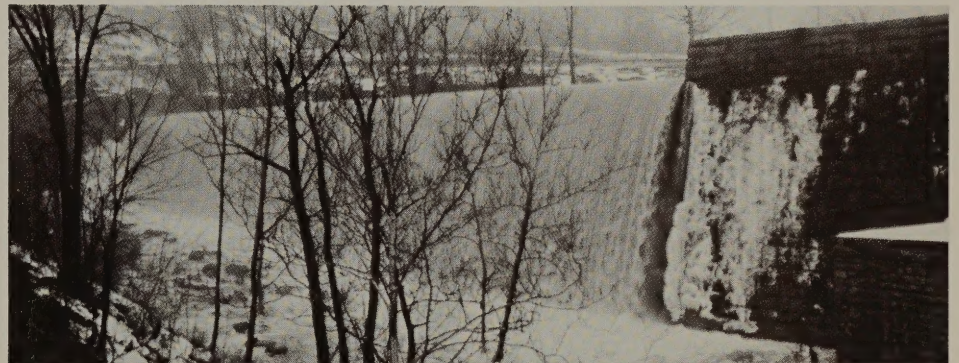
the roadway and to allow redirection of the flow to the roadway culvert. Near-peak discharges are shown in Figures 6 and 7. An overview of the project-treatment features is shown in Figure 8.

Figure 6. Near-peak discharge over spillway.

Figure 7. Near-peak discharge over spillway.

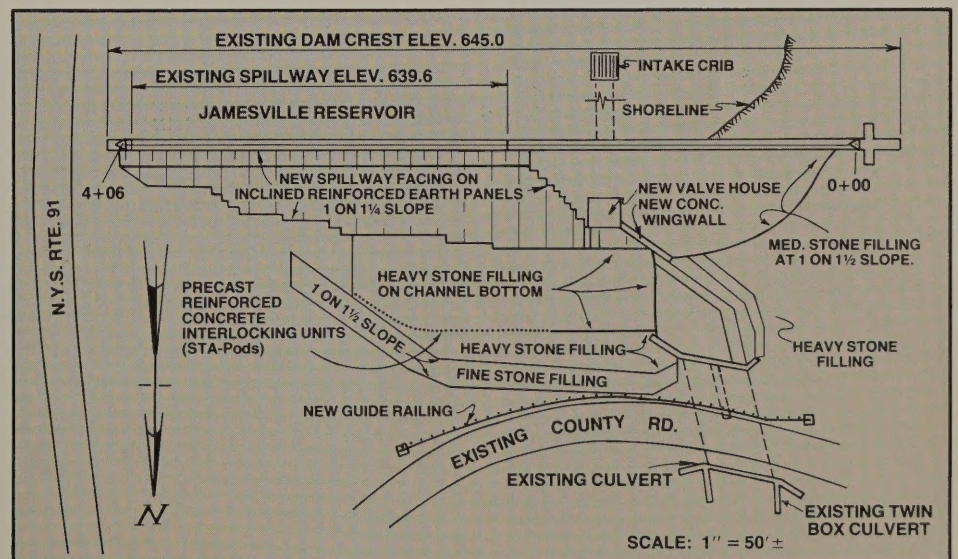
Figure 8. Site plan of dam stabilization and rehabilitation.

The delicate condition of the dam, the presence of the berm of silt against the upstream face and public pressure to maintain a pool dictated that the existing dam be strengthened rather than replaced. It was decided, from among various alternatives, to buttress the existing dam with a wedge of compacted rock fill. However, flow over a rough rock spillway surface would be destructive. Calculation indicated a flow velocity at the spillway bottom of as much as 40 ft per second under a peak discharge condition. Therefore, a smooth spillway slope was required with an immediate dissipation of energy in the adjacent channel to protect the county road and re-orient this discharge, 90-degrees to flow, toward the existing culvert and then down Butternut Creek.

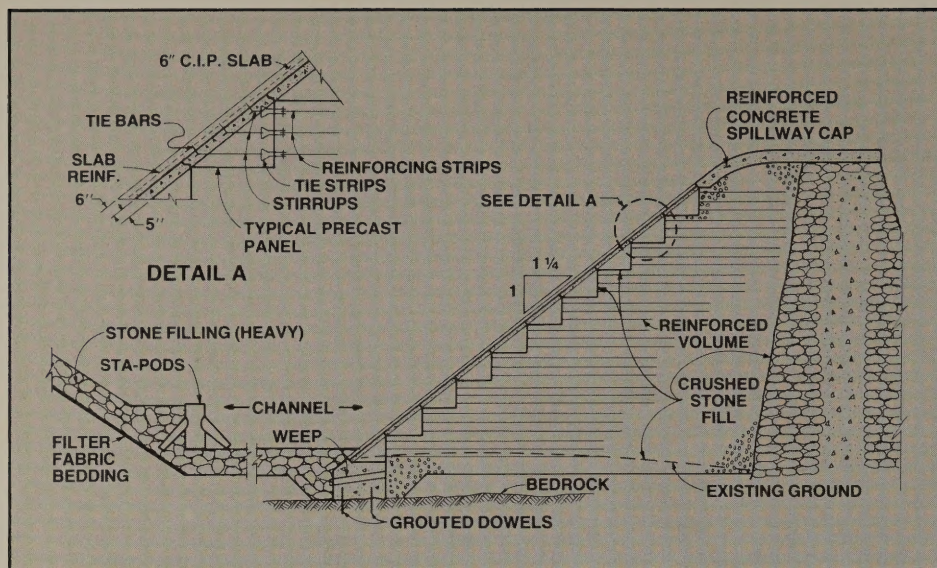
Figure 9. Typical section spillway buttress and spillway.

at panel joints. This problem was solved by pouring a six-inch-thick reinforced concrete slab on top of the panels. The slab was tied to the panels by two methods. First, the panels were specially cast with steel tie bars protruding for attachment of the slab's reinforcing steel. Secondly, the panels were cast with a rough surface finish to promote bonding to the slab. Setting forms on the sloping panels for the slab pour was no longer a problem (See Figure 11). The typical section (Figure 9) shows these details. Note that there is structural continuity of the slab to the reinforcing strips.

Provision for quickly dissipating the energy of water coming off the spillway was the next problem to be resolved. The spillway flow velocity was estimated at 40 ft per second and would impact the opposite bank less than 40 ft away. This bank supports a county road which had to remain unaffected by this project. In addition, water from the spillway must turn 90 degrees, run parallel to the new toe of dam and then change direction again to flow away from the site through a culvert. The design scheme adopted was to line the existing rock channel next to the spillway toe and the opposite stream bank with a three foot thickness of heavy stone fill. Heavy stone fill consists of rock with 50% to 100% of the pieces heavier than 600 lbs, and not more than 10% smaller than six inches. In addition, a revetment system was required for further protection of the bank supporting the existing roadway. A patented system of precast concrete units called Sta-pods was used for this purpose (See Figure 12). A typical cross-section illustrating the stream channel and bank-protection system is shown in Figure 9.

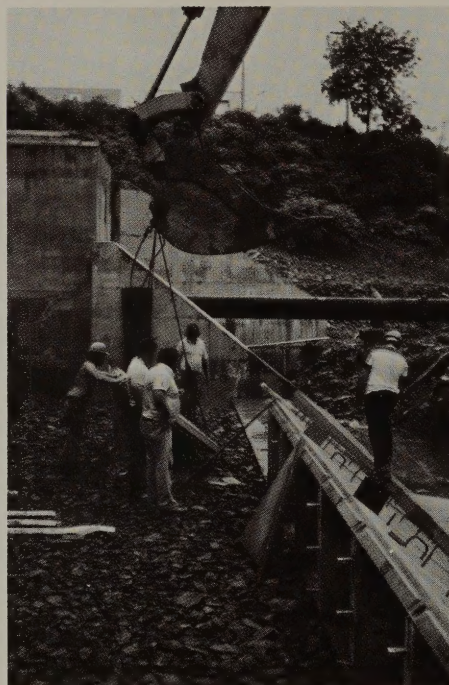
Figure 10. Initial placement of Reinforced Earth slope buttress.

The solution to the problem was to replace the rock buttress in the spillway section with a Reinforced Earth sloping buttress. Inclined panels have been used extensively in the construction of massive coal storage facilities. Figure 10 shows initial placement of these panels in this project.

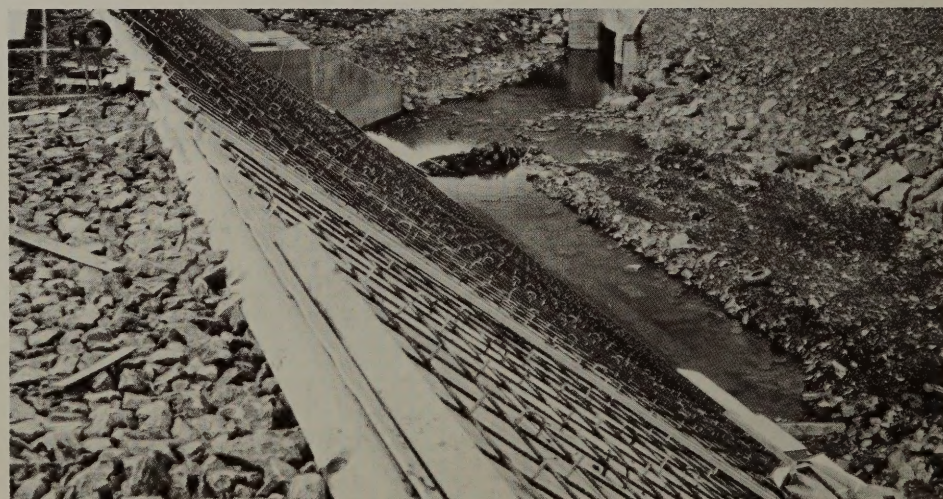
Figure 11. Reinforcing steel tied to inclined panels for slab pour.

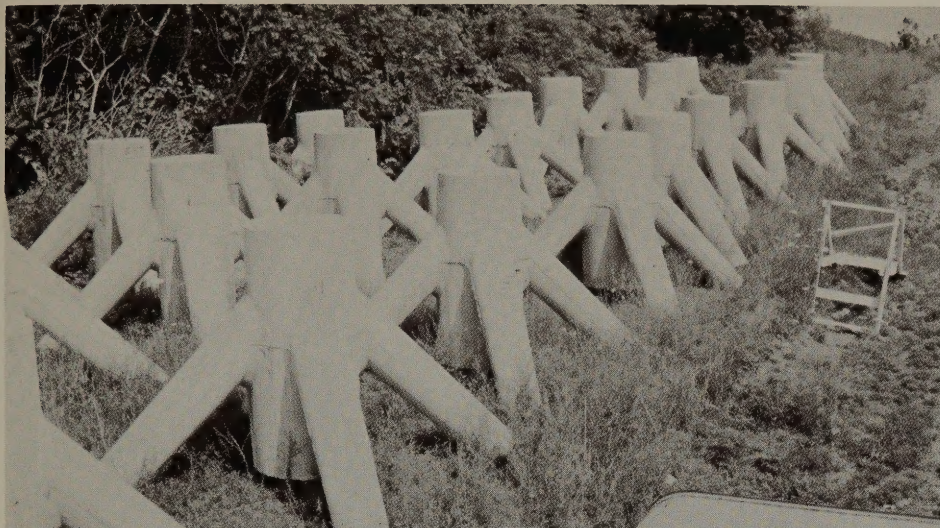
Figure 12. Precast concrete Sta-pods for additional bank support.

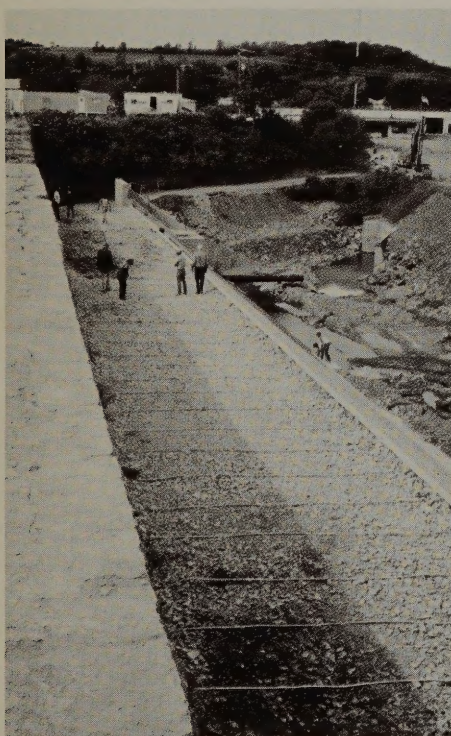
Figure 13. Reinforcing strips before backfill.

Originally, compaction was to be accomplished on 12-inch lifts with the specified number of passes related to the particular types of compaction equipment used. This was changed to compaction with hauling and spreading equipment to eliminate the possibility of fracturing the reinforcing strips (See Figure 13).

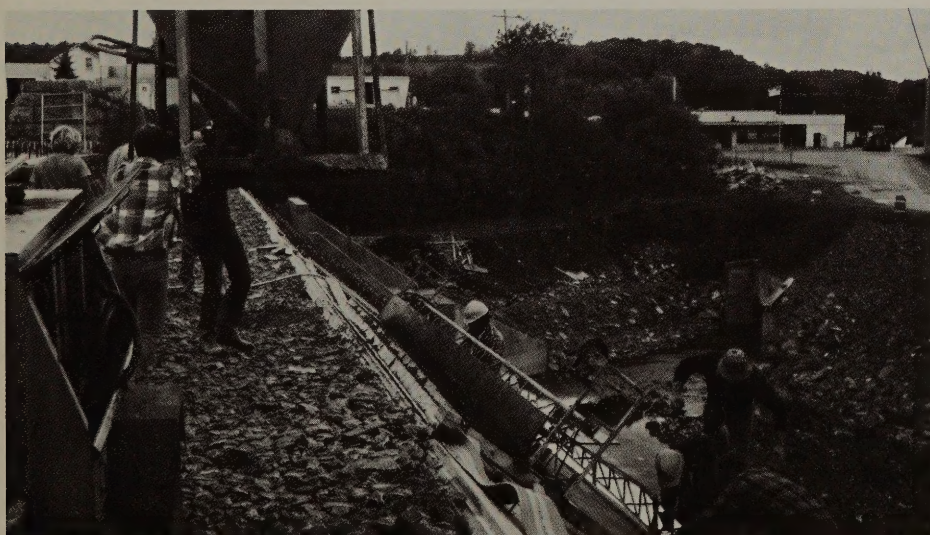
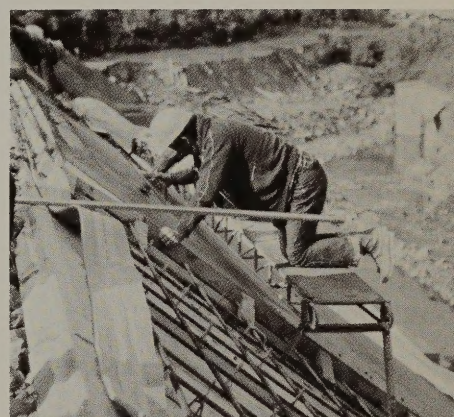
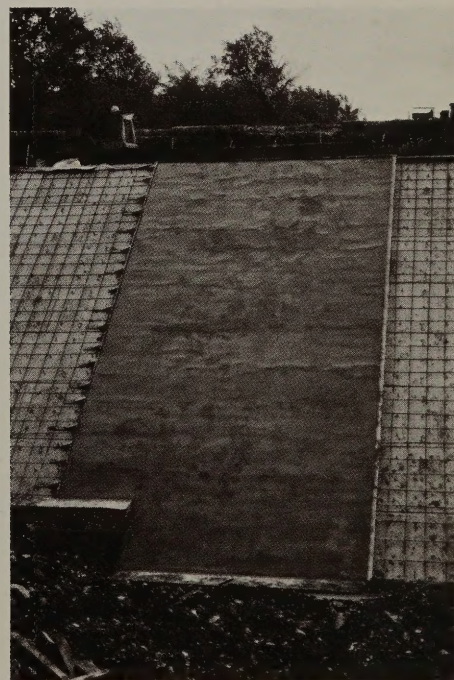
Figure 14. Concrete pour over Reinforced Earth facing.

The only other significant construction difficulties were the concrete pours on the Reinforced Earth face, and the curved pour for the spillway cap. In both cases, a low slump was critical (See Figures 14, 15, and 16).

Figure 15. Finishing the concrete slab.

Figure 16. Completed concrete slab section.
